## UNEXPECTED MOTION CONTROL

# Product Information Bulletin

PIB-PV2008-008  
Date: 21-Oct-2008

Control circuit monitoring

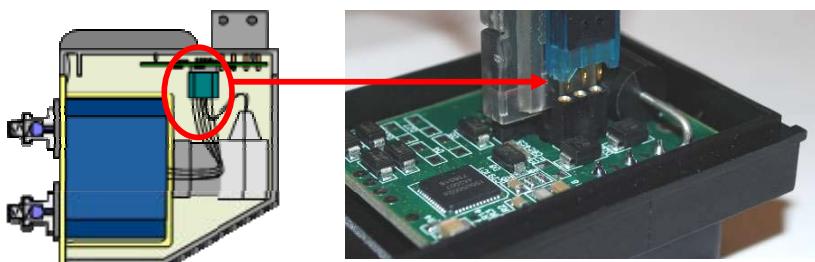
The electrical control module contains a linear variable differential transformer (LVDT) to assist in monitoring the position of the main spool for the PVG valve assembly and providing a feedback signal to a circuit board (PCB) within the electrical control module.

Sauer-Danfoss has identified that fretting corrosion can occur within an internal electrical connector between the LVDT and PCB on PVE Series 4 starting from introduction until 27-Apr-2008. The fretting corrosion in the internal electrical connector will not result in any general degradation of performance in most valve applications. However, the fretting corrosion condition can produce a false neutral indication, causing a non-anticipated valve response. When this failure mode occurs, on board fault monitoring may not be triggered.

In CAN bus systems (using PVED) fretting corrosion can cause an increased occurrence of error codes related to spool neutral.

Starting with production on 28-Apr-2008, material and geometry changes were made to the internal electrical connector to eliminate the potential for fretting corrosion and electrical failure.
