# **SERVICE BULLETIN**

**DATE**: 30<sup>th</sup> April, 2012

# MACHINE OR VEHICLE AFFECTED: ABC 3-Drum Trailers

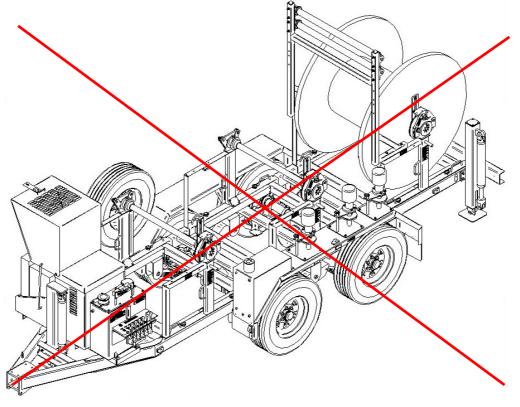
A potential manufacturing and/or design fault has been identified in the frame of these machines. It was discovered that RHS Stiffener DD2003 was not fitted to some trailers. For this reason, Redmond Gary Australia is imposing a temporary load procedure restriction for these trailers. The loading of the rear drum only load case is strictly not allowed as this may lead to cracking and subsequent failure just forward of the Front Spring Hangers.

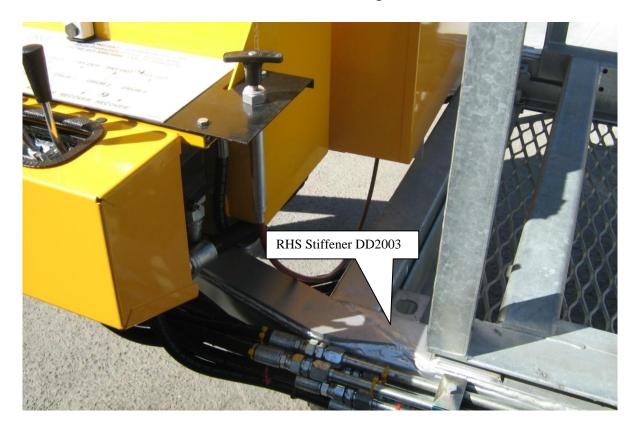
Note: Some trailers have fixed drum frames and others have removable drum frames as illustrated here. In both cases this stiffener is required.

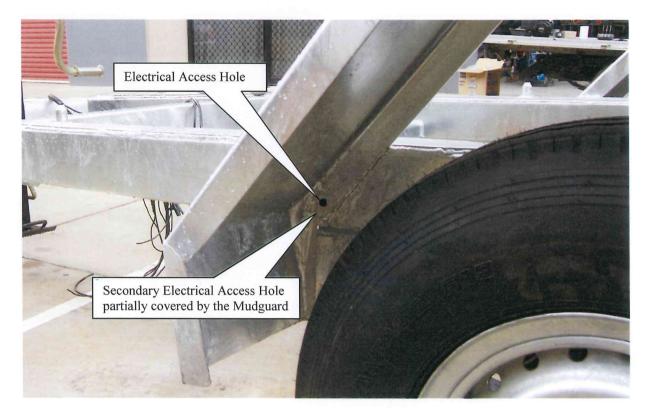
Machine owners must immediately implement an inspection of the Front Suspension hanger welding and the electrical access hole directly under the front of the mudguards. If there is any sign of cracking, the trailer is to be withdrawn from service until repair and the additional RHS stiffeners added.

Additionally an inspection is needed to confirm that there is not a second electrical access hole directly under the front of the mudguards. If a second electrical hole is found then this trailer should be withdrawn from service until an additional RHS stiffener is added.
