SERVICE BULLETIN

MACHINE OR VEHICLE AFFECTED: TF Model MEWPs

RISK IDENTIFIED: Structural Cracks in Main Boom Rest

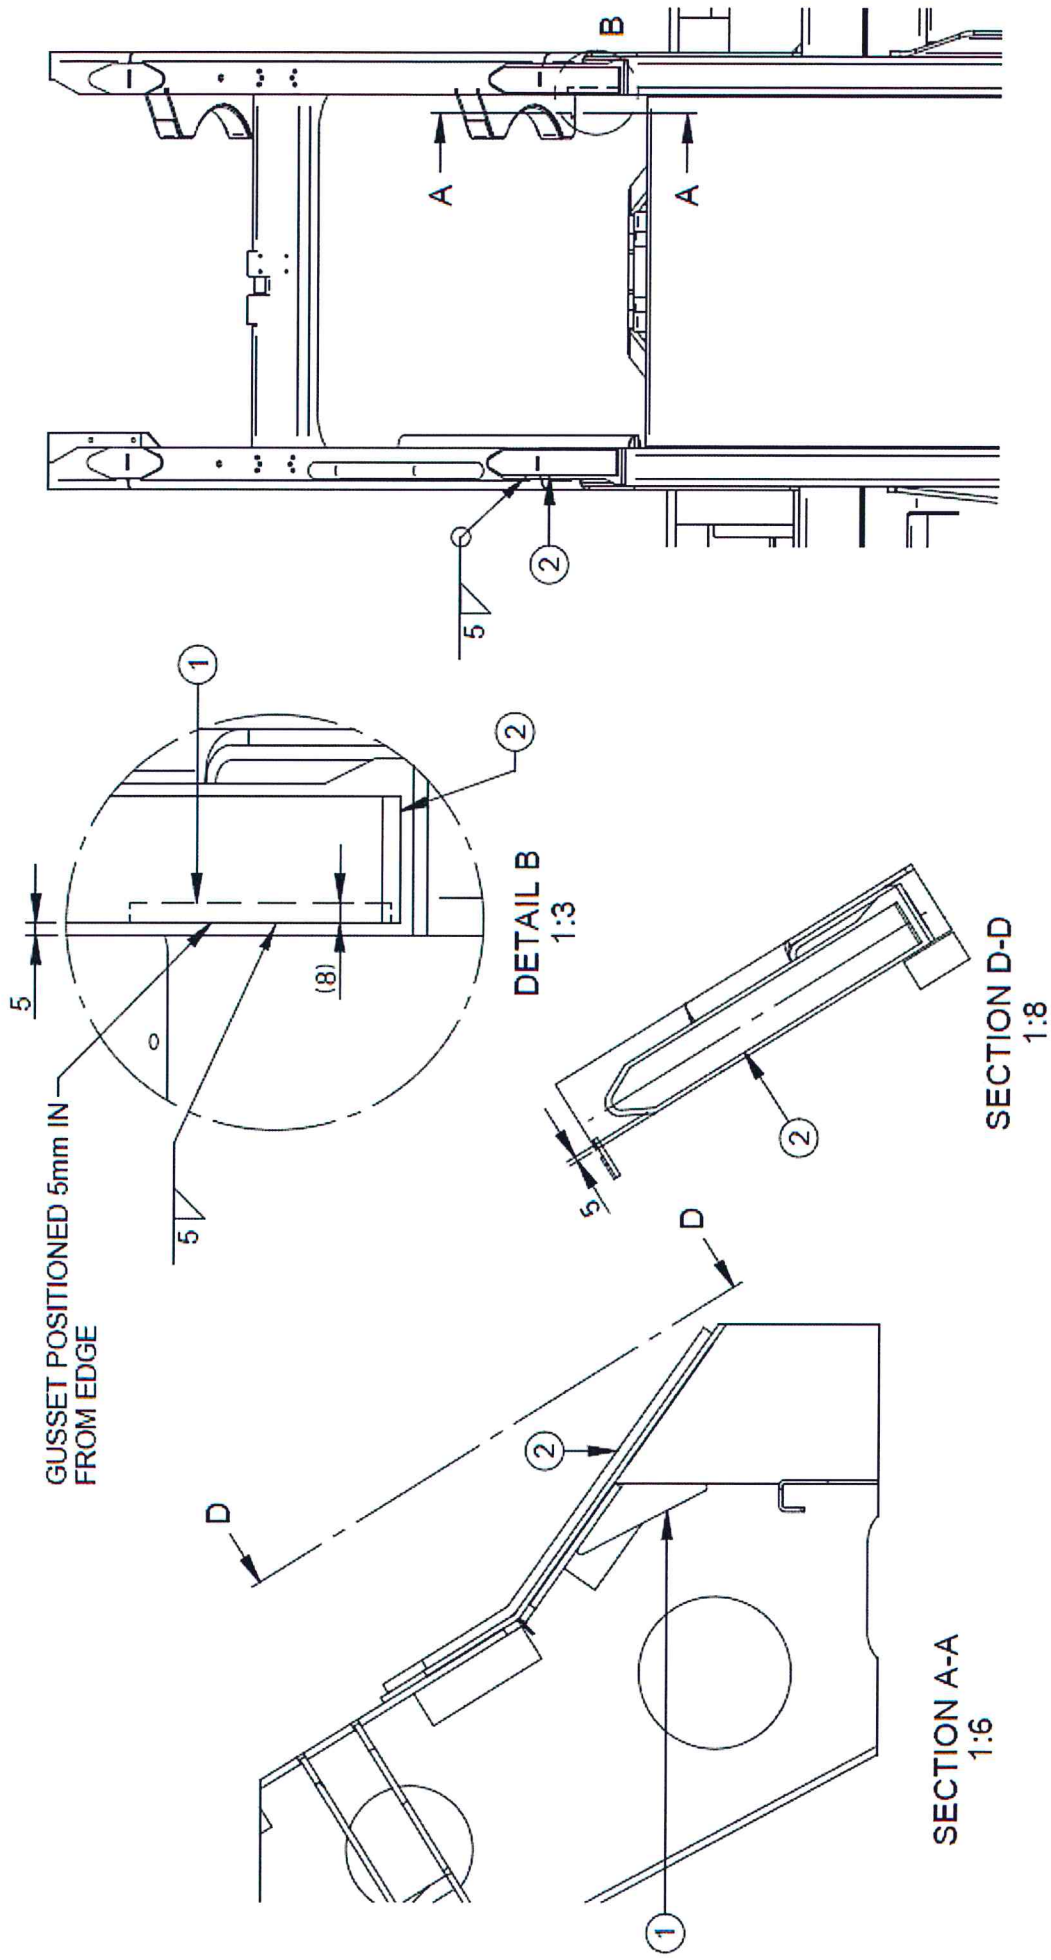
DESCRIPTION: Structural cracks can occur in the lower part of the main boom rest

1. Drill a 3mm hole in the end of each crack
2. Grind away all welds containing any cracks
3. Re-weld all welds that were ground away
4. Consult the assembly drawing found on page 2 and mark out all areas receiving new plates. Grind away surrounding paint to ensure a clean welding surface.

5. Make 2x Top doubler plates and 2x Bottom gussets. Drawings can be found on pages 3 & 4.
6. Weld in all 4 additional plates in accordance with the assembly drawing (page 2).
 - a. The electrical cable on the RHS must be well protected during welding to avoid damage.
7. Once cool, re-paint all exposed surfaces.
