# SERVICE BULLETIN

Rev. No.	Date	Author	Description
Original issue	5 December, 2017	Andrew Danks	TF Basket upgrade

TF Model MEWPs with TL basket retro-fit.

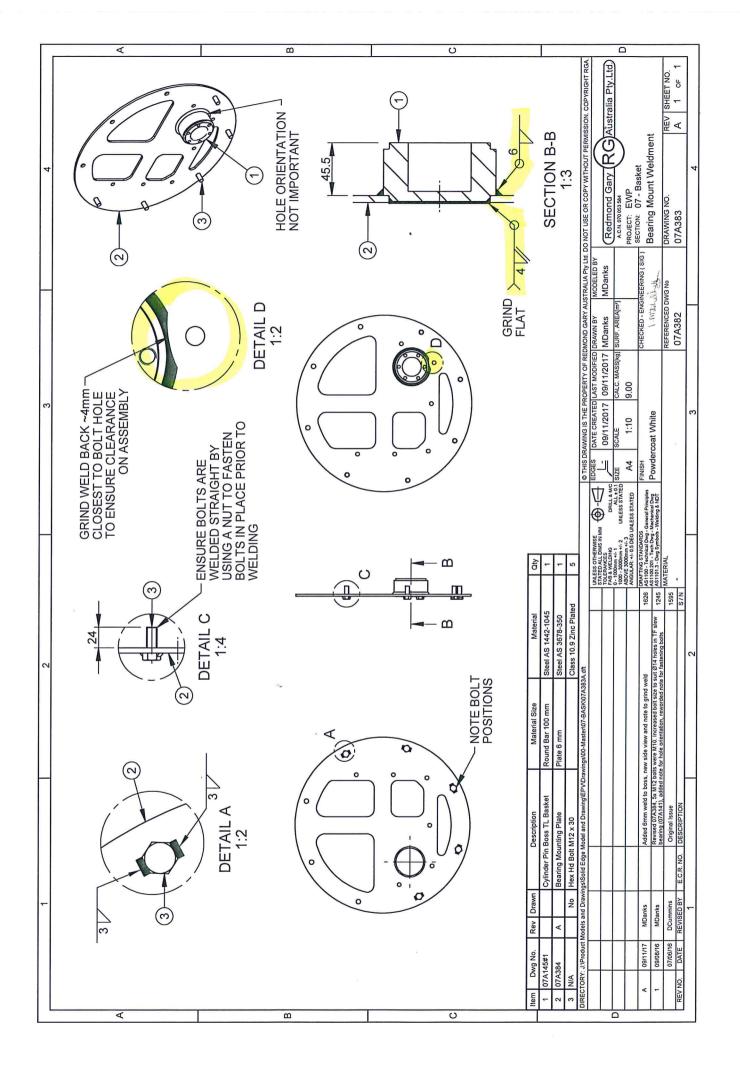
Rotating basket cylinder anchor point weld failure.

- Raise boom to access underside of the basket.
- Remove under-basket cover and inspect Item 8 check that it is secure. If it is loose or out of square with the base plate, it will need to be repaired.

A detailed repair procedure is available from Redmond Gary Australia, on request.
