# SERVICE BULLETIN

Rev. No.	Date	Author	Description
Original issue	19 February, 2018	Andrew Danks	2.5t SLCT

2.5t SLCT up to and including SN 11127.

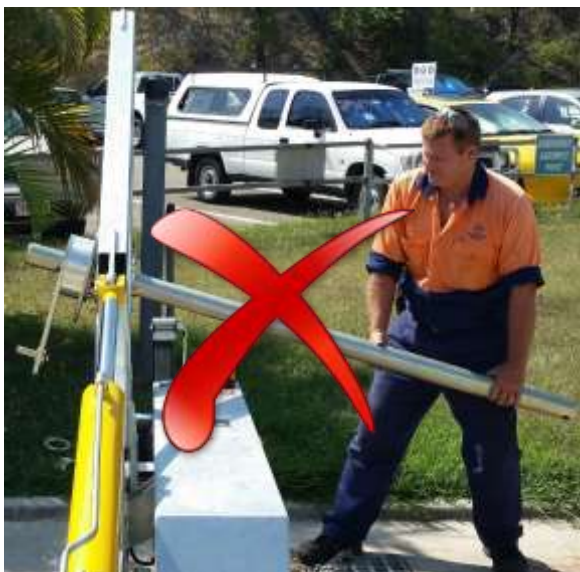
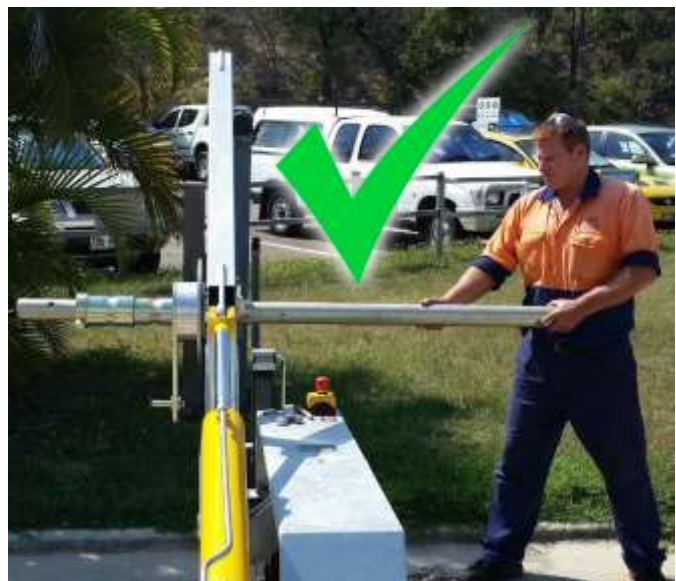
The roller bearing potentially suffers damage due to handling of the spindle shaft.

Keep spindle horizontal during disengagement with drum and spindle bearing housing as much as possible to avoid damage to the bearing seal and bearing.

If the spindle needs to be lowered to the ground please assure to completely remove it from both bearing housings and put it onto the ground separately.
