# SERVICE BULLETIN

## TL MEWPs – CAN Drop Out Issue

Doc. No.: 248047-18

Date: 15-11-2018

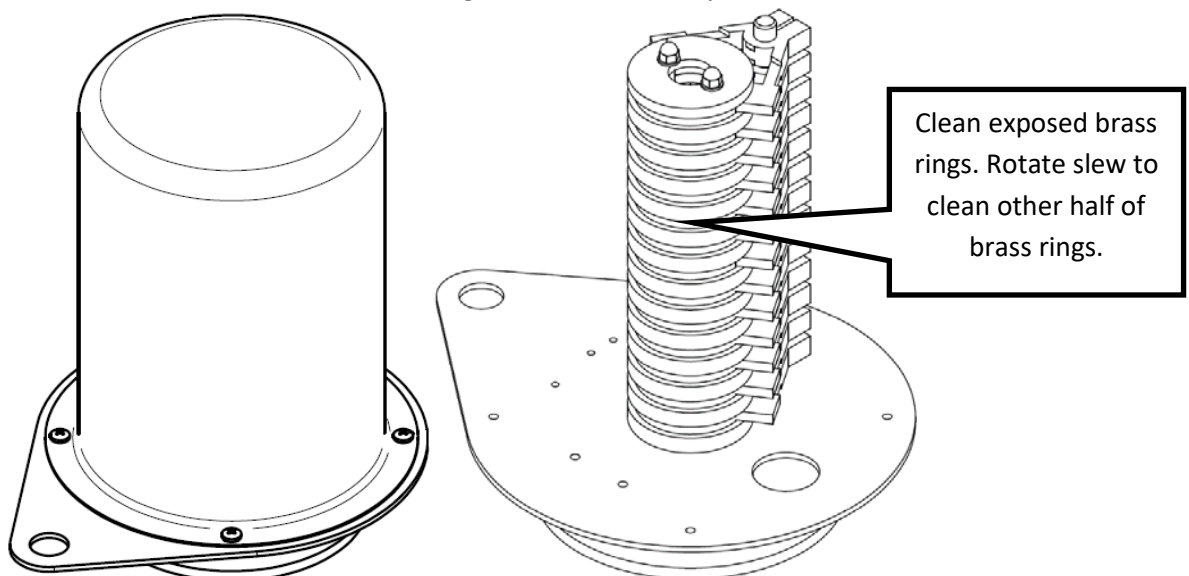
The operator's will primarily experience interruptions of radio remote control typically when slewing. The HMI will show Fault code 3 – ICND not online during the drop out. This will self-clear when the ICND CAN node connects again. If the CANbus suffers a large disruption then the HMI will likely display a 'cannot connect to PLC' message.

Figure 1: Electrical slip ring assembly with and without metal cover.

1. Turn MEWP on, engage the PTO and set-up jacklegs.
2. Raise the main boom up to gain access to the inside of the turret through the top (the slip ring assembly is located in the center of the turret). Turn off PTO and isolate power.
3. Remove the metal cover to see the ring and brush assembly.

4. Using fine sandpaper clean the exposed brass rings half and spray with contact cleaner. Also, gently rub the face of each contact on the brush assemblies using the sandpaper.  
NOTE: The 2 main slip rings to clean can be identified with the brown wire and white wire connected to the brush assemblies.
5. Exit the turret, turn power back on, engage PTO and then slew the turret 180° when safe to do so. Turn off PTO and isolate power.
6. Get back into the turret and clean the other exposed half of the brass rings as per Step 4.
7. Ensure that each brush assembly is being forced onto the brass rings, and not catching on the black plastic spacers.
8. Bolt the metal cover back on
9. Turn power back on, engage PTO and then test turret slew functions and other radio remote functions. Ensure there are no more interruptions.
