SERVICE BULLETIN

Basket Levelling Drive Operating Characteristics

Doc. No.: 601028-03

Applicable Vehicles:	All TL model MEWP's
Issue Date:	01 February 2021
Overview:	This bulletin provides information regarding the physical construction and operational characteristics of the worm gear drive responsible for levelling the basket. The objective of this bulletin is to inform MEWP operators on how the levelling system works and address any safety concerns.

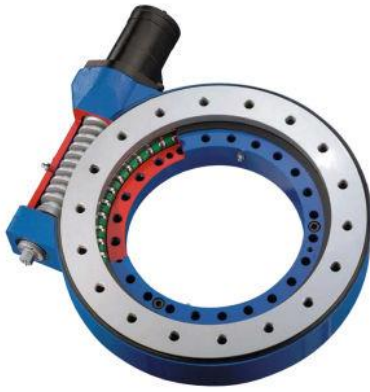
Figure 1 – Representation of a similar assembled worm gear drive

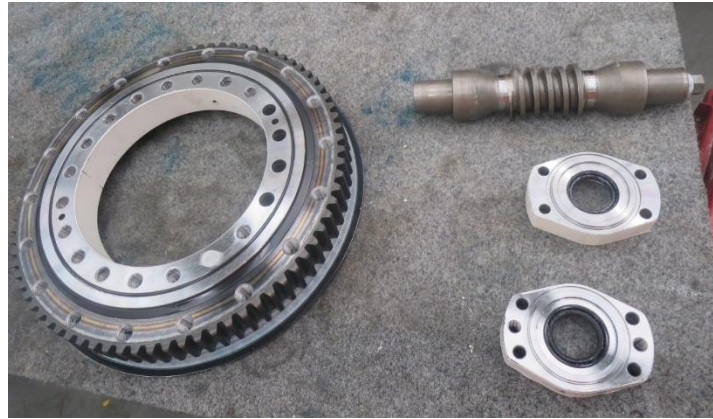
Figure 2 - Disassembled RG worm gear drive

Redmond Gary has received feedback from some customers that operators can experience vibration and noise during levelling of the basket. To investigate this matter, RG has completely disassembled numerous new and ‘noisy’/in-service levelling drives. RG can confirm that no noteworthy damage, faults, abnormalities or excessive wear has been found.

The noise and vibration experienced can be attributed to characteristics of the gear tooth profile used and the low rotational speeds that both the hydraulic motor and gear set operate at. This behaviour is further exacerbated by small variations in tolerances and backlash from the levelling drive manufacturing process, which appears to explain why only some levelling drives experience issues and others do not.

Even though our investigations have not identified any units with faults, RG recommends operators continue to monitor the levelling drive and report any instances where vibration or noise increases significantly during service.
