SERVICE BULLETIN

MACHINE OR VEHICLE AFFECTED: PoleERU

RISK IDENTIFIED: Structural Cracks in Boom Sheave Wheels

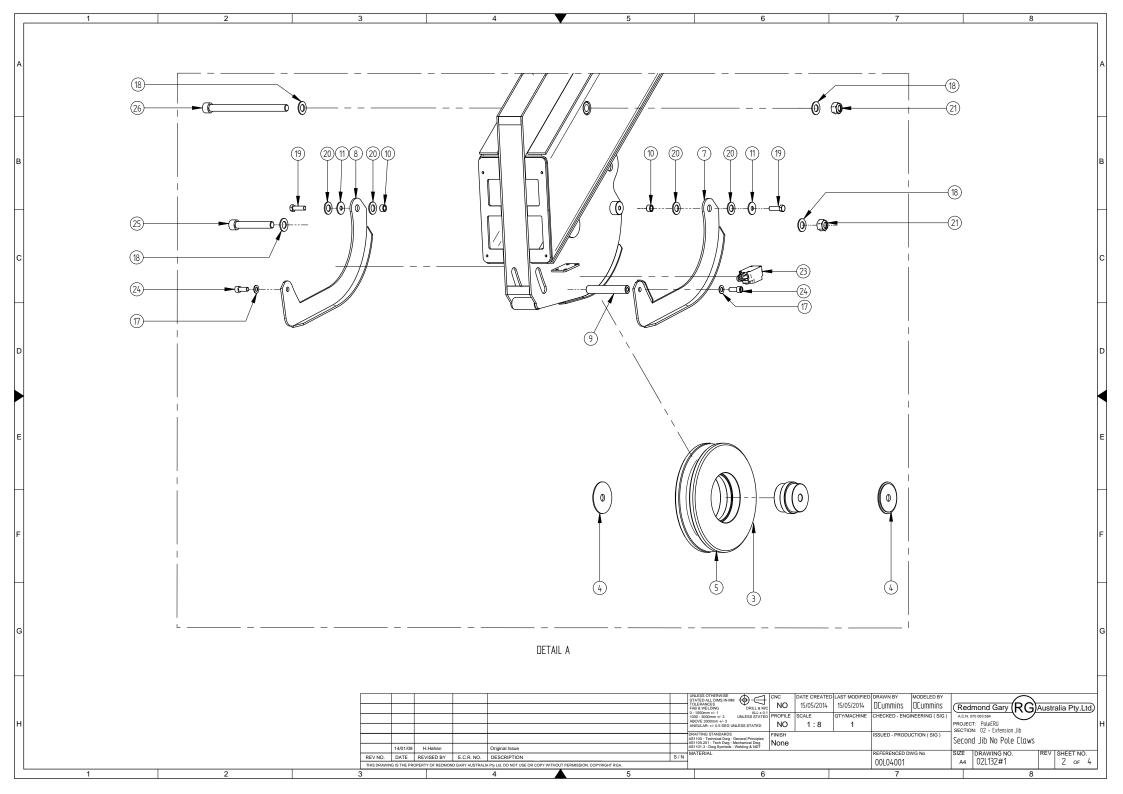
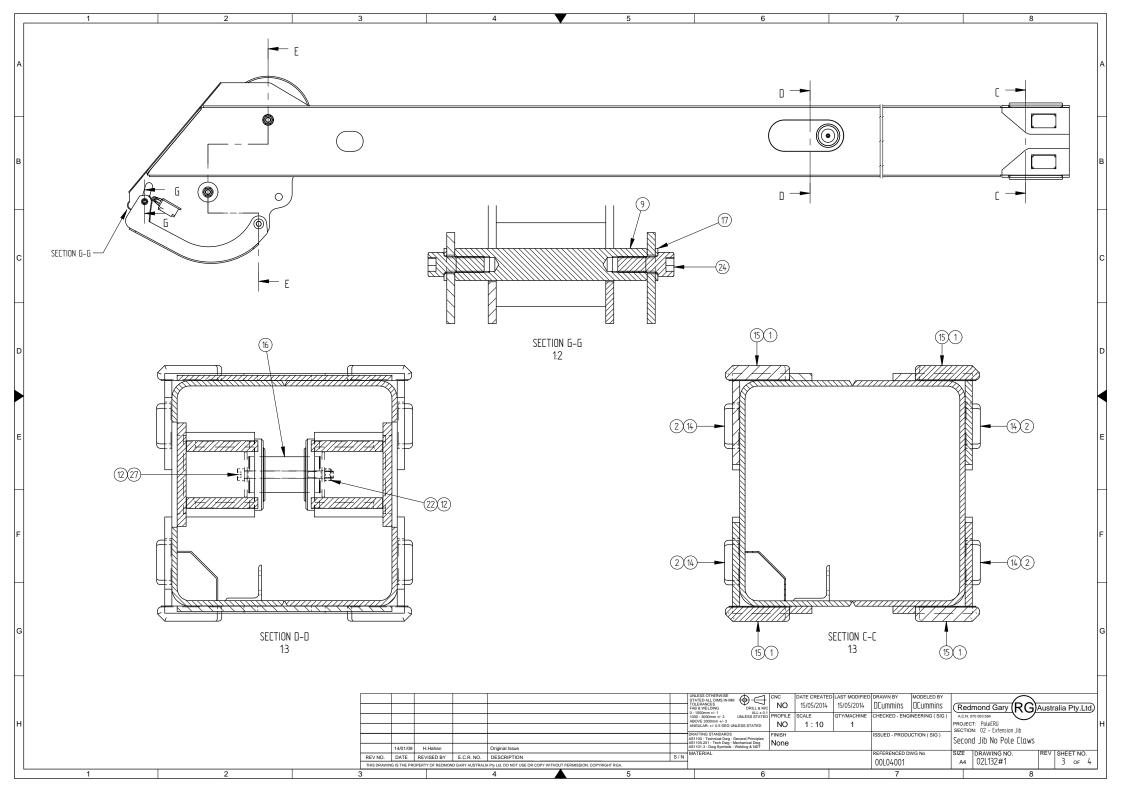
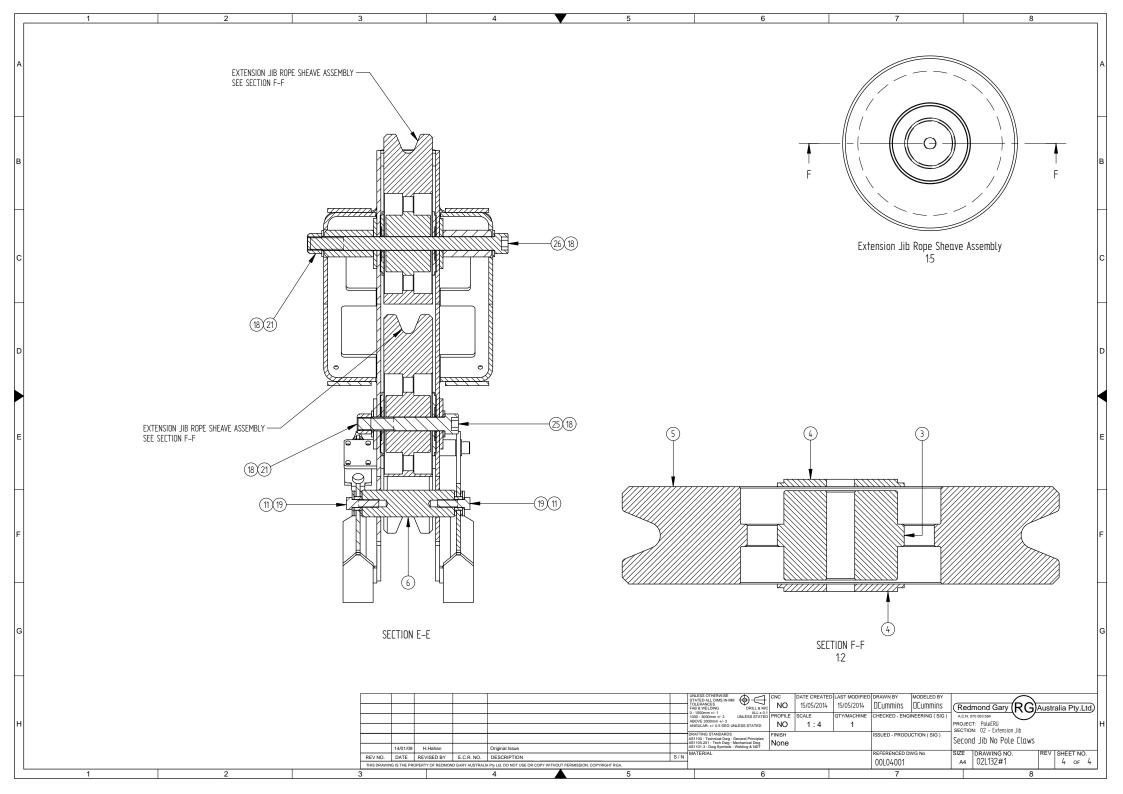
1 2	3	4	/	5	6	7 8	
А Д Д Д Д Д Д Д Д Д Д Д Д Д		•					A A E
	e B B	1 02L012 2 02L013 3 02L043 4 02L044	Rev Draw 1 1 A1 A1	Wear Pad F Wear Pad F Sheave Bea Sheave Bea	Packer Plate aring Spacer aring Spacer 2	SEALE 150 Material Sheet 1 mm Zincanneal Sheet 1 mm Zincanneal Round Bar 100 mm AS 1442/1045 Cold Drawn Black Round Bar 100 mm AS 1442/1020 Cold Drawn Black	Qty 4 2 4
E A A		5 02L128 6 02L130 7 02L133LH 8 02L133RH 9 02L216 10 02L218 11 02L219	A1	2nd Boom V Rope Stop I Rope Stop F Rope Stop F Rope Stop F	Veldment LH RH Boss Pivot Spacer	Black Nylatron GSM Round Bar 24 mm AS 1442/1045 Hot Rolled Round Bar 20 mm AS 1442/1045 Cold Drawn Plate 3 mm AS 3678-350	2 1 1 1 2 2 2
F O O O		12 02L232 13 02L233 14 03L011 15 03L015 16 91L4002 17 N/A	1	Wear Pad S Wear Pad B Cyl. Mount B	ib End Cover Side 3rd Jib Bottom / Top 3rd Jib Bolt 2 for 2nd Jib	Sheet 3 mm Stainless Steel Grade 304 Floor Plate 3 mm Aluminium 5251 0 U.H.W.M.P.E. Nylatron GSM Round Bar 40mm AS1444/4140 Hard Chrome Plated ASTM F436	2 1 4 4 1 2

G		18 N/A 19 N/A 20 N/A 21 N/A 22 N/A 23 N/A	No No No No No No	Hex Head B M20 Nylon V Nut Nyloc M Nut Nyloc M	oolt M12 x 40 Washer 3 mm 120 18	ASTM F436 ASTM F436 Blackwoods P/N: 0094 4316 Class 12 Class 8 ASTM F436	4 2 4 2 1 1
		25 N/A 24 N/A 25 N/A 26 N/A 27 N/A	No No No No	Socket Hd C Socket Hd C Socket Hd C	Capscrew M12 x 30 Capscrew M20 x 130 Capscrew M20 x 280 Capscrew M8 x 100 UNAS OTHERNIE UNAS OTHERNIE UNA	Grade 12.9 Grade 12.9 Grade 12.9 Grade 12.9 Grade 12.9 Grade 12.9 ISJOS/2014 DElummins Redmond Gary RGAustralia	2 1 1 1
	REV NO. DATE REVISED BY E.C.R. NO. THIS DRAINING IS THE PROPERTY OF REDUKING GARY AUST		JT PERMISSION. COPYRIGH	T RGA. 5	Freak wellowing Desilitation Desilitati	TY/MACHINE CHECKED - ENGINEERING (SIG) 1 ISSUED - PRODUCTION (SIG) REFERENCED DWG № REFERENCED DWG № SECOND 12 - Extension Jib Second Jib No Pole Elaws REFERENCED DWG № SIZE DRAWING NO. REV SHE	F

- 1. Rotate pole claw assembly and slide back and pin to second boom.
- 2. Remove the hook
- 3. Remove the wire rope so that it is clear of the two Sheave Wheels.
- 4. Remove the M20 Cap Screw and Nyloc nut from the centre of the lower Sheave Wheel taking care to support the Sheave Wheel when removing the capscrew.
- 5. Remove the lower Sheave Wheel
- 6. Repeat steps 4 and 5 for the upper Sheave Wheel.
- 7. Visually inspect the Nylatron Sheave Wheels for hair line cracks. If any cracks are found the Sheave Wheel **MUST** be replaced.
- 8. Check condition of bearings and replace if worn.
- 9. Reassemble the Sheave Wheels into the boom when tightening the M20 capscrews. They are to be torqued to 557 Nm or 410 Ft lbs.
