## UNEXPECTED MOTION CONTROL

# Product Information Bulletin

PIB-PV2008-008  
Date: 21-Oct-2008

Control circuit monitoring

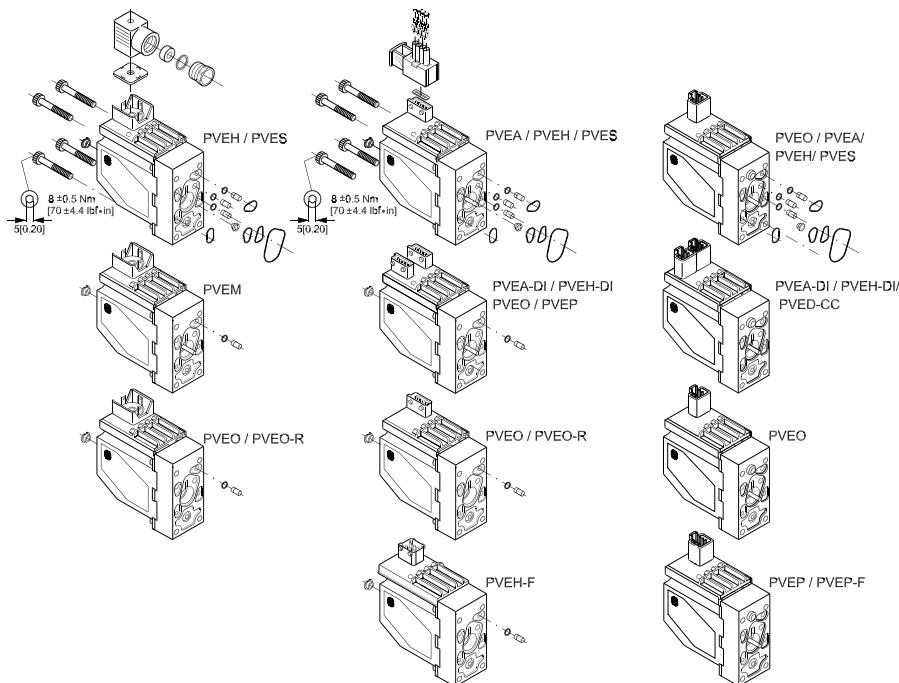
**Montage af PVE**  
**Installation of PVE**  
**Montage von PVE**  
**Installation de PVE**

Pakningen i PVE stikket samt pakningerne til de enkelte ledninger, er afgørende for at korrekt tæthed af stikket opnås.

The seal in the PVE connector and the seals for individual conductors are crucial for correctly sealing the connector.
